Otter Rock Water District Water System Feasibility Study and Planning Support

January 2018

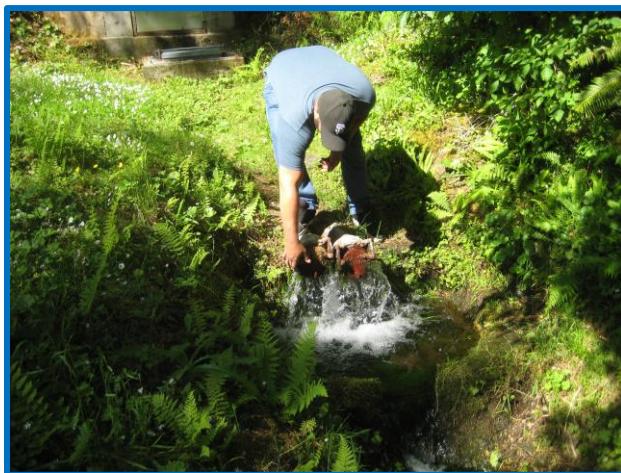
Figure 2.2: Spring #2 Overflow Pipes

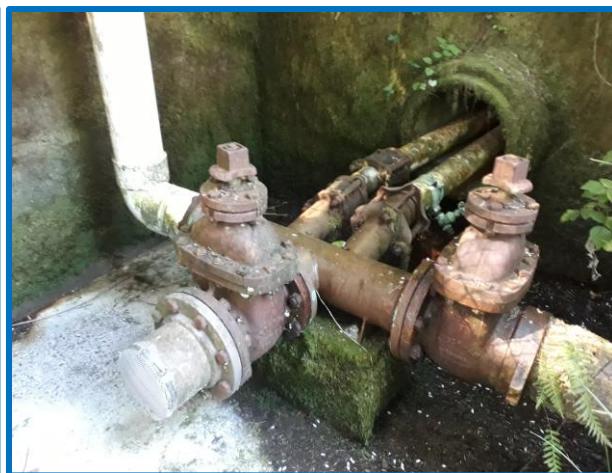
Figure 2.3: Spring #1 Manifold Valving

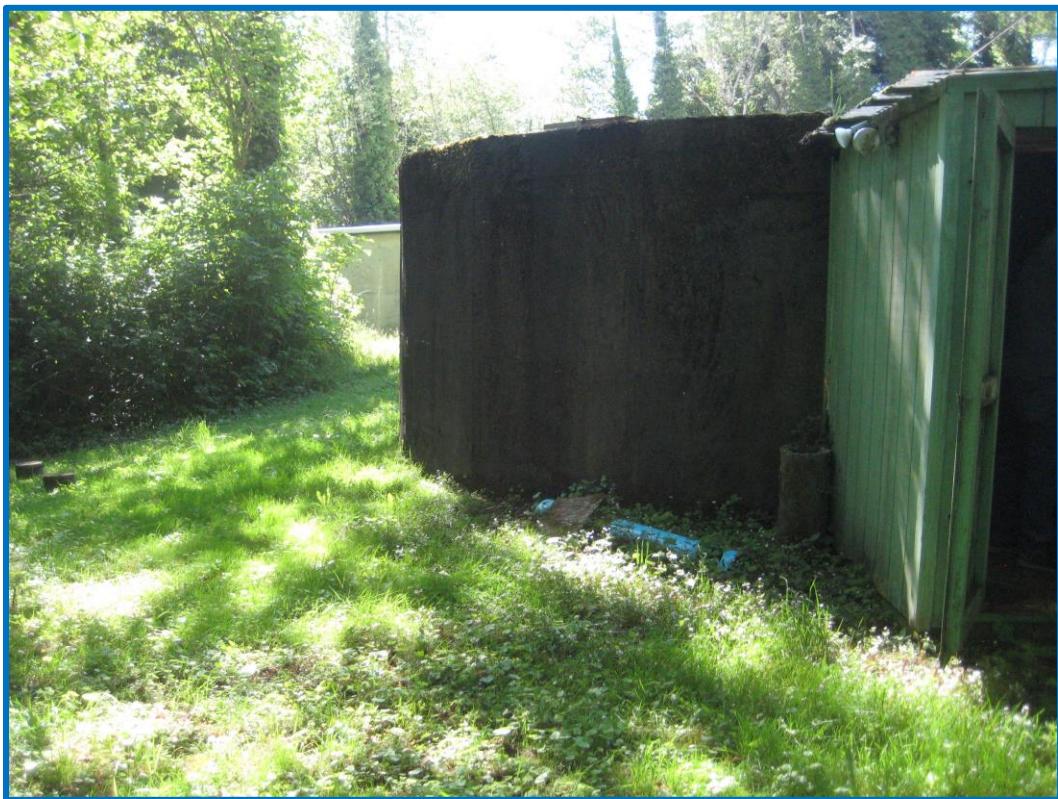
Figure 3.1: 30,000-gallon Tank

This cost estimate assumes there will be the need for structural upgrades. The interior of the tank will be sand-blasted to remove any corroded cement. Any piping fixtures in the tank will need to be replaced with stainless steel fixtures. Following sand blasting, the interior of the tank will need to be recoated with either a multi-layer epoxy coating or a polyurethane coating as discussed in Section 3.1.1.

Depending on the conclusion of the structural analyses, it may be more cost effective to demolish and replace the tank entirely. Table 3.4 shows the overall project cost estimate to construct a new 30,000-gallon tank.

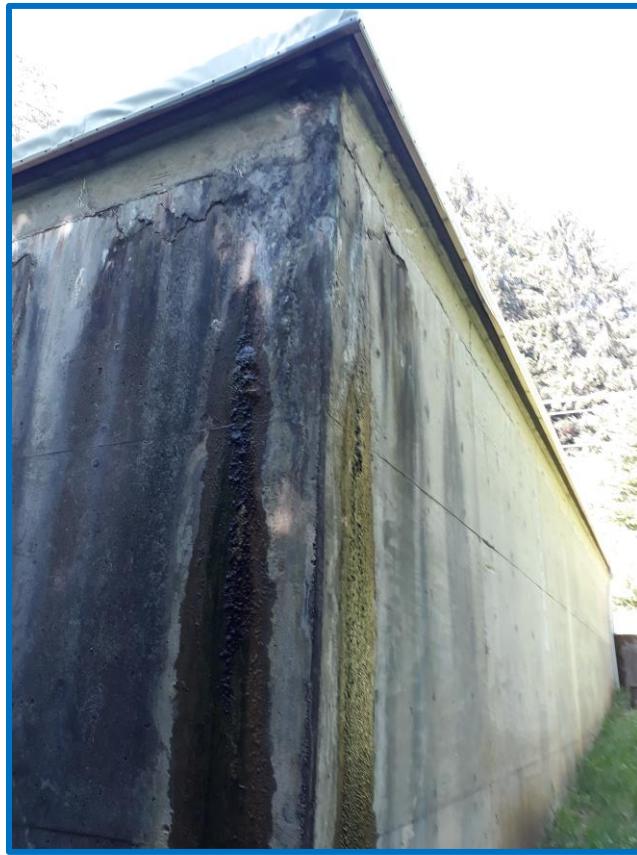
The larger 300,000-gallon cement tank has been showing obvious signs of degradation. The west corners of the tank show signs of concrete spalling and grouting of the west corners has been required to slow down what appear to be substantial leaks in the tank, visible in Figure 3.2. The roof was replaced in September of last year with a white EPDM rubber roofing membrane. The interior of the tank was cleaned in 2016, and the tank is periodically flushed with chlorine for disinfection. As indicated on photos taken

during the interior cleaning, there is substantial pitting in the tank walls and floor, especially around the steel fixtures that affix the various transmission pipes to the tank.

Figure 3.2: Northwest Corner of 300,000-gallon Tank

This cost estimate assumes there will be the need for structural upgrades. Operation staff indicates one roof support span within the tank appears broken. The interior of the tank will be sand-blasted to remove any corroded cement. Any piping fixtures in the tank will need to be replaced with stainless steel fixtures. Following sand blasting, the interior of the tank will need to be recoated with either a multi-layer epoxy coating or a polyurethane coating as outlined in Section 3.1.1.

Depending on the conclusion of the structural analyses, it may be more cost effective to demolish and replace the tank entirely. Table 3.6 shows the overall project cost estimate to construct a new 300,000-gallon tank.

Based on the above, and taking into account the cost associated with a structural analysis, it is recommended new tanks be constructed.

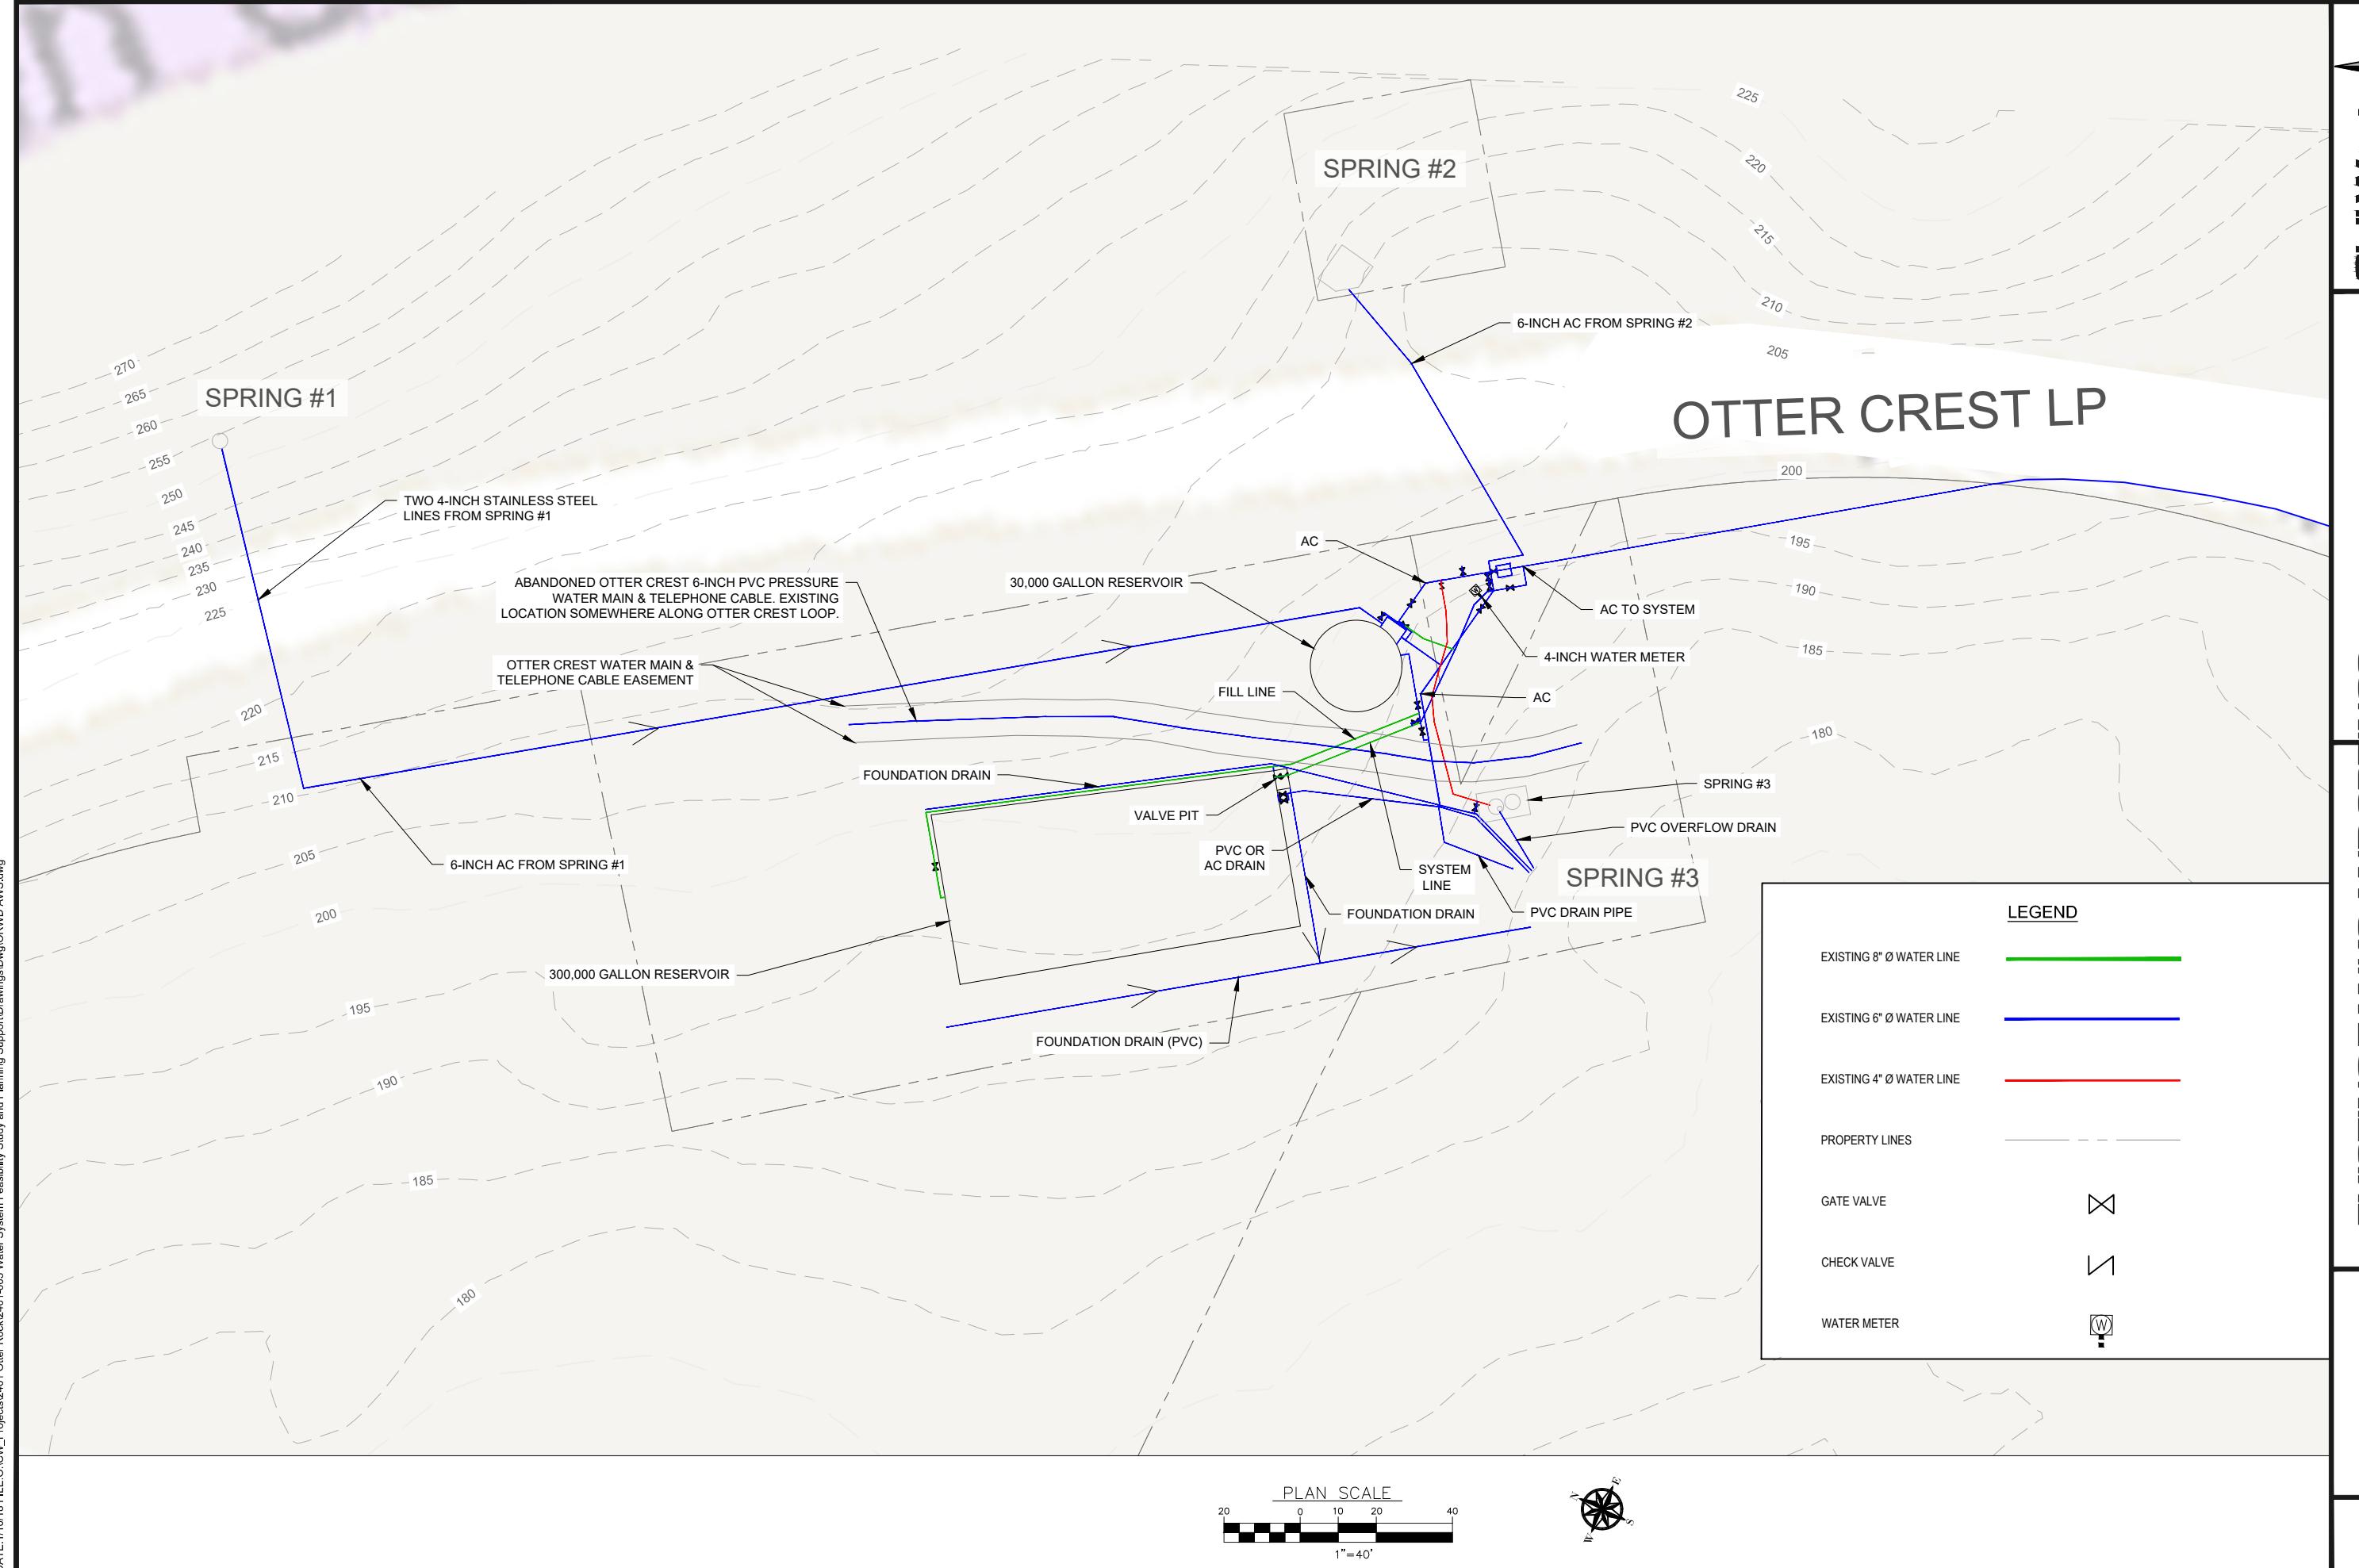
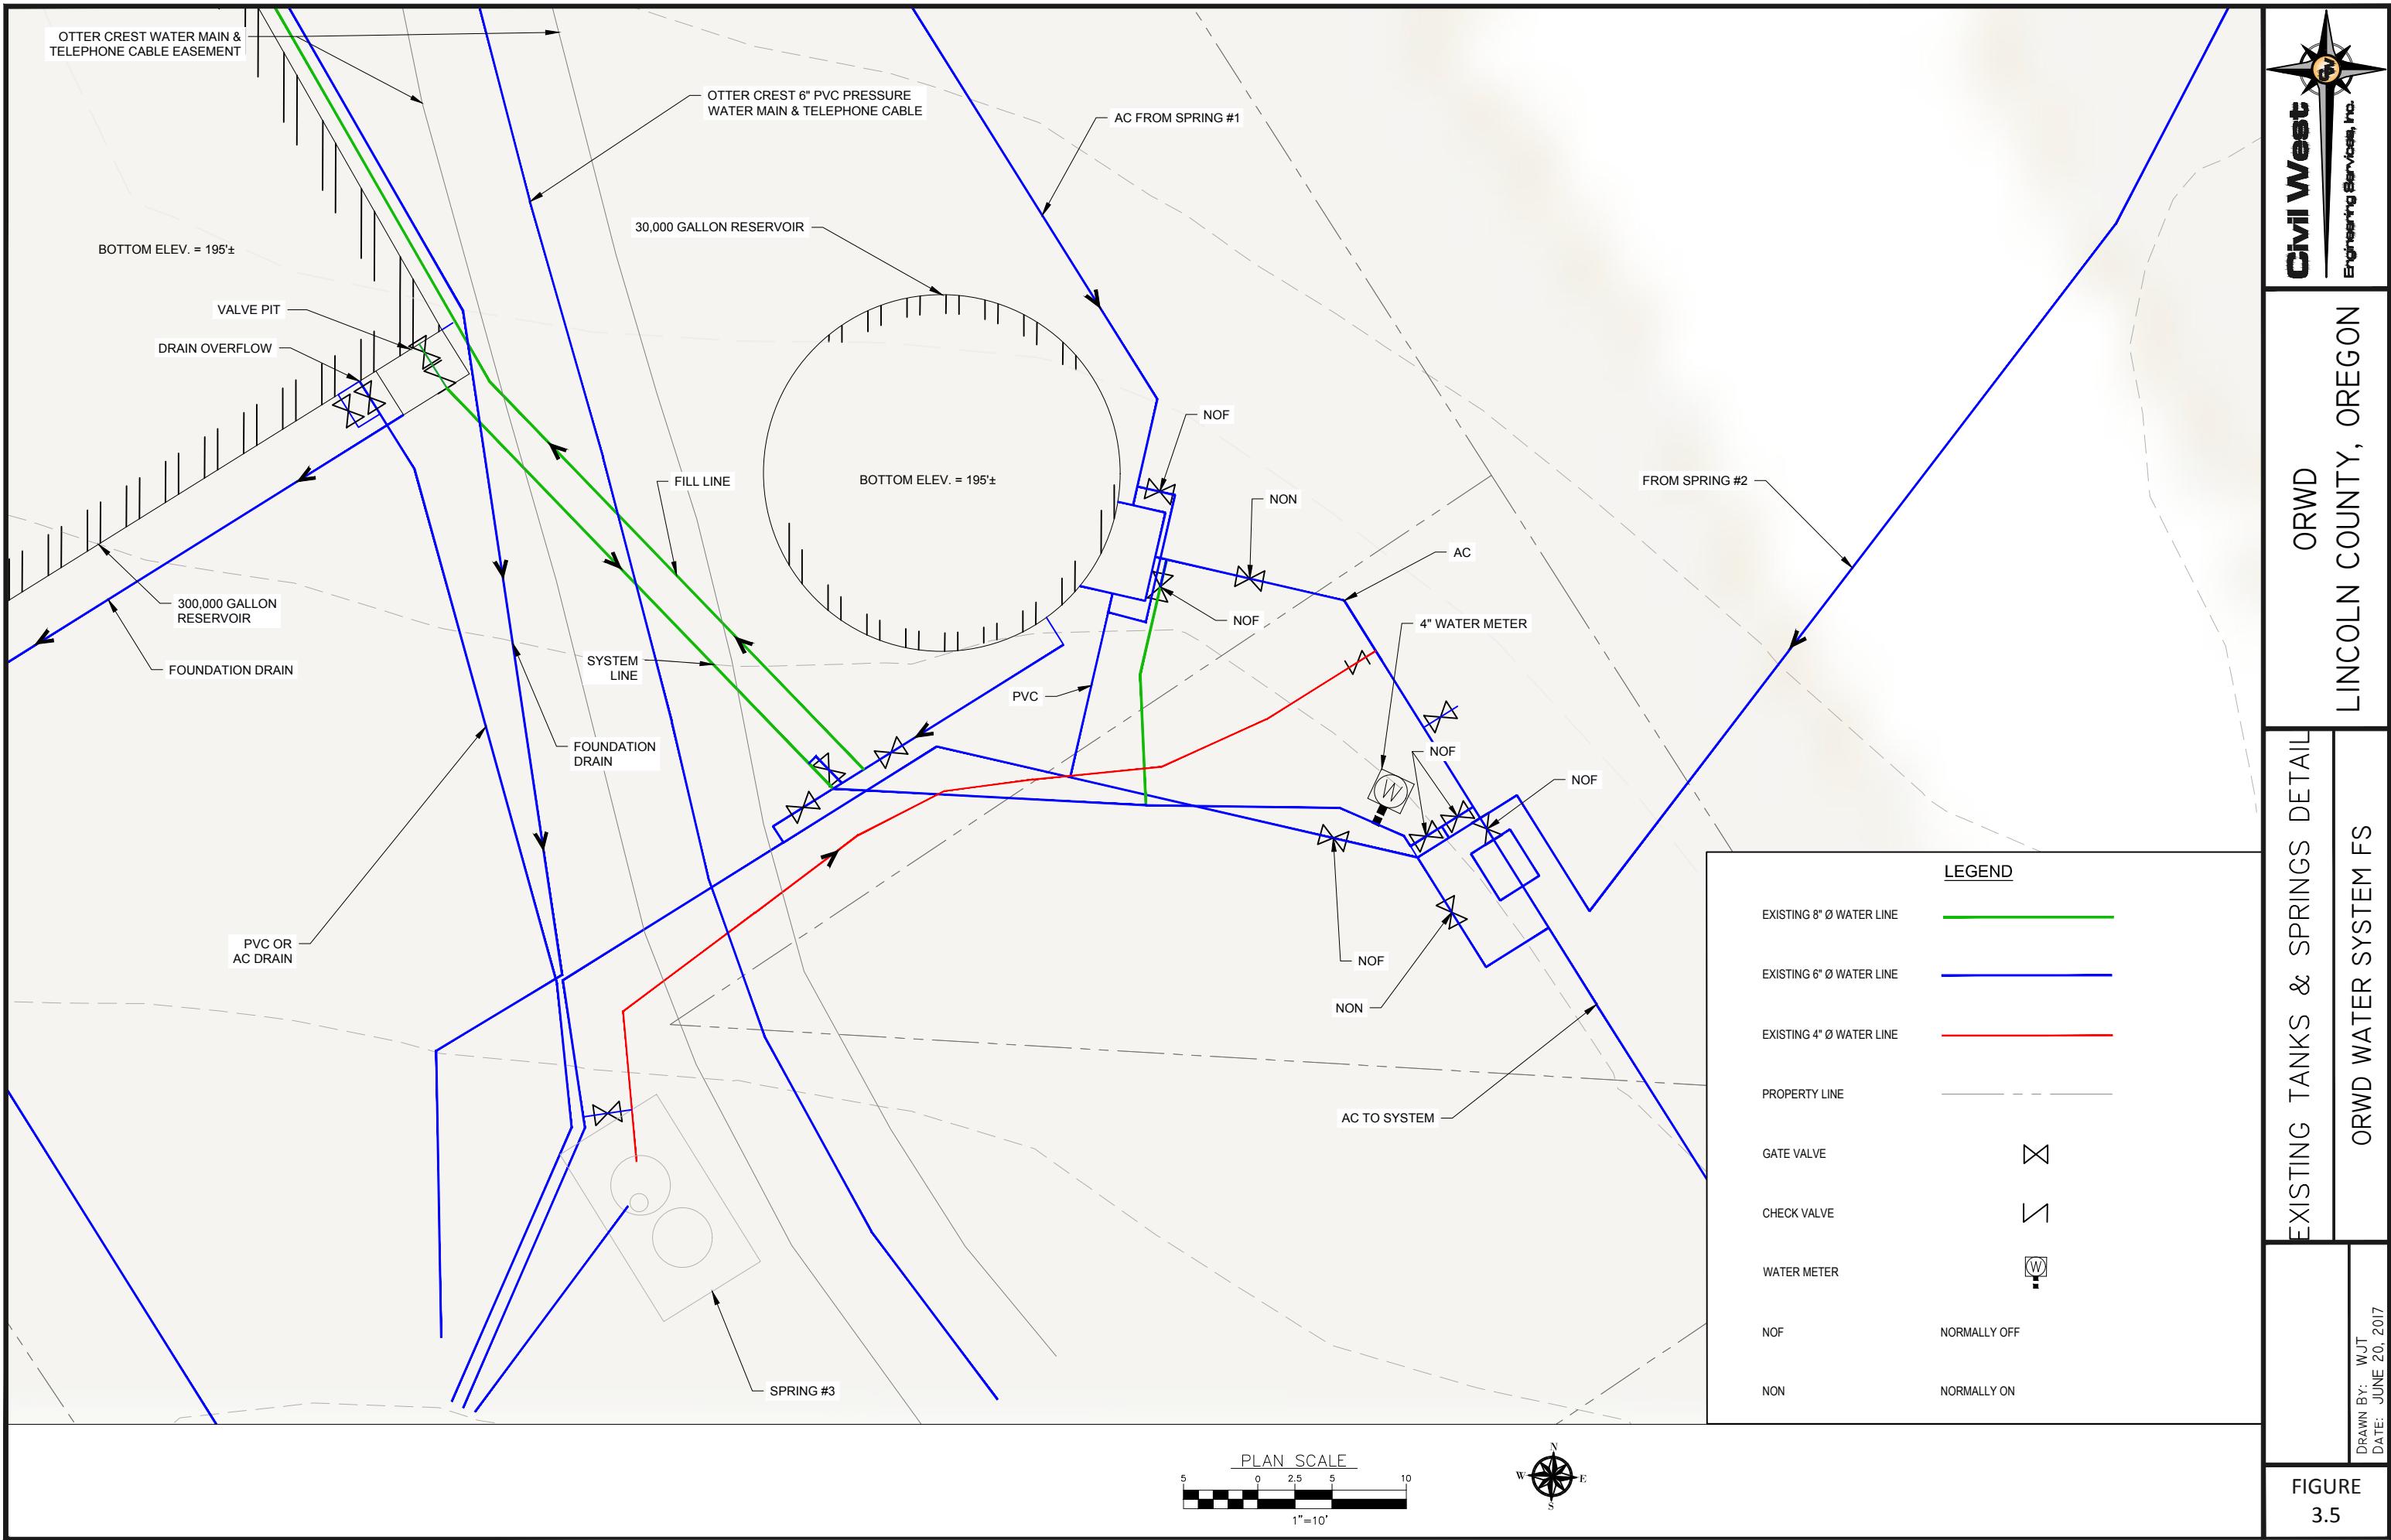
FIGURE
3.4

Figures 3.4 and 3.5 show the existing valving and distribution piping system for the spring sources and the tanks. The piping material consists of a variety of materials including PVC, AC, stainless-steel, and galvanized iron. The galvanized iron pipe is an abandoned pipe that runs from Spring #2 to the small tank.

Spring #2 is gravity fed into a 6-inch AC pipe that runs under Otter Crest Loop and to the small tank. Spring #1 is gravity fed into two 4-inch stainless steel lines, one of which is a supply line and one of which is an overflow line, that run under Otter Crest Loop, into what appears to be a custom-built brass manifold, and into a 6-inch AC line that runs to the small tank. Source water from Spring #3 is pumped up from the spring in a 4-inch PVC pipe to the same 6-inch AC line that runs from Spring #2 to the small tank. Backflow into Spring #3 is prevented with a check valve.

As shown on Figures 3.4 and 3.5, the overflow for the small tank serves as the feed line for the large tank via a 6-inch AC line. Overflow for the small tank may also be routed to a riprap pad beneath Spring #3. An 8-inch line of unknown material runs off the 6-inch AC small tank overflow line to the intake for the large tank. The large tank has an 8-inch line that runs to a 6-inch AC line that provides the community with water. The large tank also has a 6-inch drain overflow line that runs to the riprap pad beneath Spring #3. The large tank has two foundation drains, one on the east side and one on the west side of the tank. The foundation drains also run to the riprap pad beneath Spring #3.

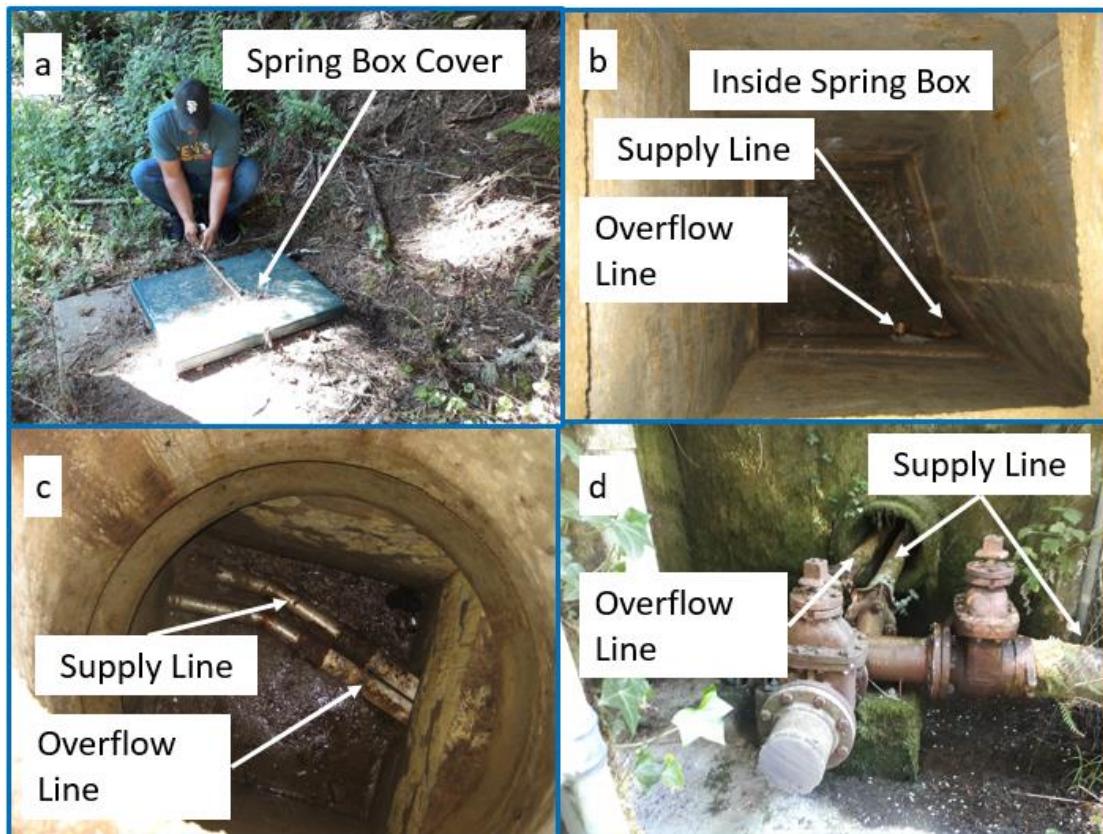
Figure 3.7 shows (a) the springbox cover, (b) the inside of the springbox, (c) the adjacent access manhole, and, (d) the manifold on the west side of Otter Crest Loop. The springbox cover consists of a lid restraining bar with a pad lock, which is difficult to open. Replacement of the pad lock with a corrosion resistant lock would make accessing the springbox much more efficient. Aside from the lock, the springbox itself appears to be in good condition. The access manhole, however, has significant leaks coming from the bottom and through the wall penetrations that need to be repaired. Figure 3.7c shows moisture on the bottom of the manhole. Left unrepaired, the continual moisture will lead to structural degradation of the manhole.

Figure 3.7: Spring #1 Source, Pipes, and Appurtenances

The piping and appurtenances associated with Spring #1 were installed about 40 years ago and are well past their service lives. Upgrades are recommended to maintain the structural integrity of the existing springbox and service access manhole, to ensure that overflow is routed away in a safe manner, and to allow for maximum control over the effective operation of the spring. The existing 4-inch stainless steel supply and overflow lines should be replaced from the service manhole to the manifold along with the installation of new 4-inch stainless steel to HDPE transition couplings. The condition of the culvert routing the supply and overflow lines is unknown – a thorough inspection of the culvert needs to be conducted prior to running the new pipe to ensure structural stability. The culvert may need to be replaced if there are signs of compromised structural integrity, however this is not included in the cost estimate. The manifold block wall will need to be replaced with a new retaining wall, as well as new fencing around the manifold to ensure security. All the valves and couplings near the manifold are recommended for replacement. Replacement of the 6-inch PVC from the manifold to the large tank is accounted for in Section 3.2.2.

Spring #1 cost estimate includes rehabilitation of the access manhole, installation of new transition couplings and 4-inch HDPE supply pipe and overflow pipe from the spring to the manifold, rehabilitation of the overflow outfall structure east of the manifold housing, replacement of the valving and couplings at the manifold and replacement of the manifold retaining wall. Table 3.9 shows the cost estimate for upgrades to Spring #1.

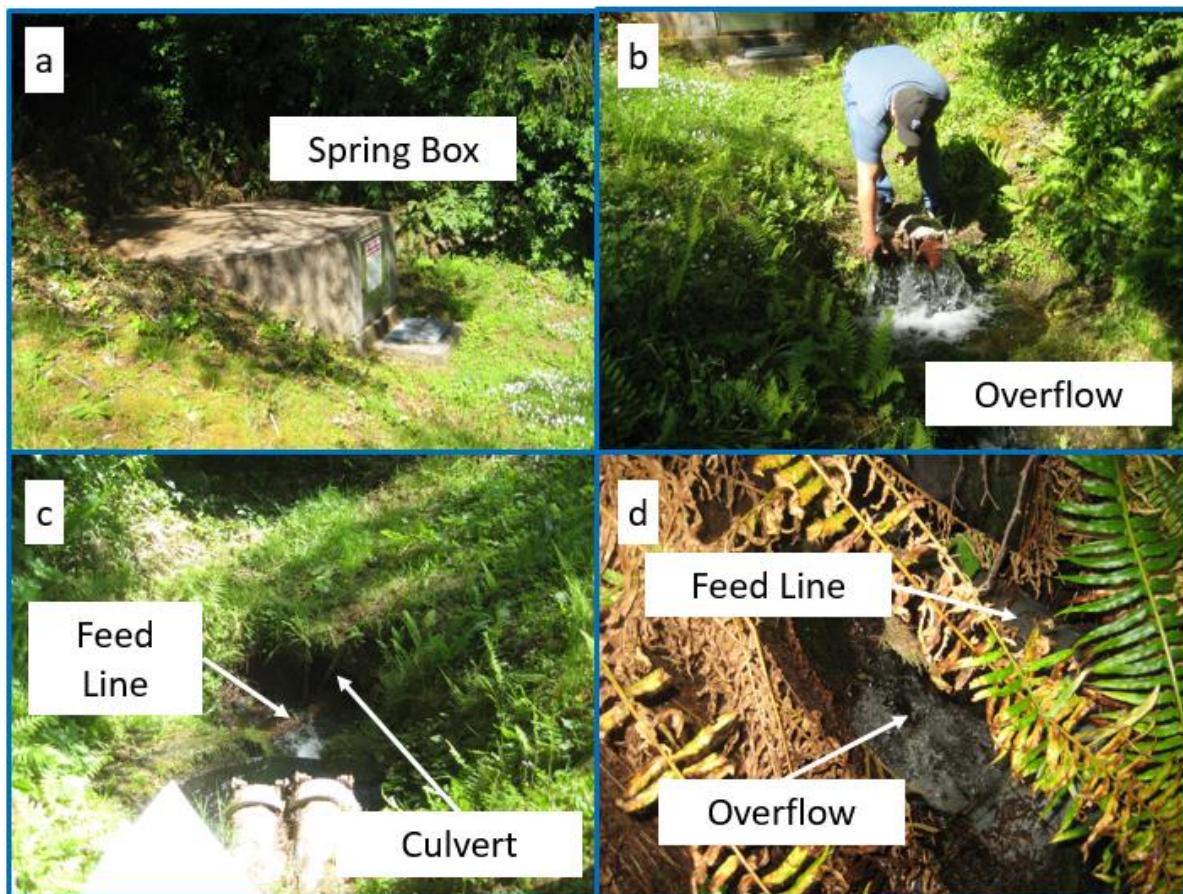
The feed line from the spring to the small tank used to be a 6-inch galvanized steel pipe. The galvanized steel pipe, however, was abandoned at some point in the past, and was replaced with the 6-inch PVC pipe discussed above. The current feed line and the overflow water share the same conduit. During periods of high overflow, the culvert can backup and flow over Otter Crest Loop, causing minor flooding. The current supply pipe takes an immediate right angle following its exit from the culvert and goes to the small tank.

Figure 3.8 shows various components of Spring #2: (a) the outside of the springbox, (b) the overflow pipes, (c) the feedline and the culvert that goes beneath Otter Crest Loop, and (d) the feedline and overflow water coming out of the culvert. It is recommended that the existing 18-inch culvert remain in place to route overflow and surface flow across the Otter Crest Loop. The existing supply line through the culvert will be removed and an engineered riprap outfall pad will be installed on the west side of Otter Crest Loop. Directional bore drilling will be used to construct an 8-inch pipe from the springbox across Otter Crest Loop to the tanks.

Figure 3.8: Spring #2 Source, Pipes, and Appurtenances

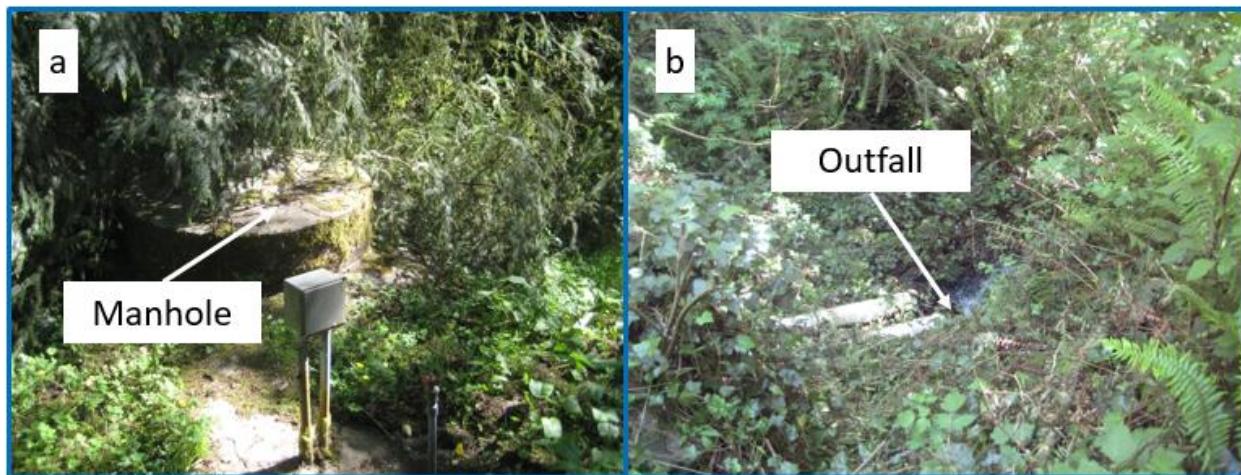
Of the three springs, Spring #3 produces the only direct TC+ hits. The infrequent use the spring may contribute to the positive hits – prolonged periods of inactivity allows for the bacterial growth in the pipes, valves, and appurtenances. Spring #3, unlike the other two springs, feeds into the small tank via a submersible pump encased in a 48-inch diameter manhole. As groundwater exfiltrates from the ground up into the manhole, the submersible pump pumps the water via a 4-inch PVC pipe to the 6-inch AC feed line from the Spring #2. The source water then goes into the small tank. Figure 3.9 shows (a) the manhole for Spring #3 and (b) the outfall which includes overflow for Spring #3, overflow for the large tank, drain for the large tank, and the foundation drain for the large tank.

Figure 3.9: Spring #3 Manhole and Outfall

Like the other two springs, the pipes and appurtenances surrounding the Spring are recommended to be upgraded. However, unlike the other two springs, Spring #3 has a pump and float switch that need replacement. The existing 4-inch PVC line that runs to the small tank will need to be replaced with a new HDPE line. The outfall beneath Spring #3 appears to be cutting into the existing bank and will need to be replaced with an appropriately engineered riprap outfall energy dissipater.

Upgrades for Spring #3 include replacement of the submersible pump and float switch, replacement of pipes and appurtenances associated with the spring, and installation of a riprap energy dissipater. Table 3.11 shows the itemized cost estimate for upgrades required at Spring #3.
