## Operations Report: Otter Rock July 2026

### Base Operations

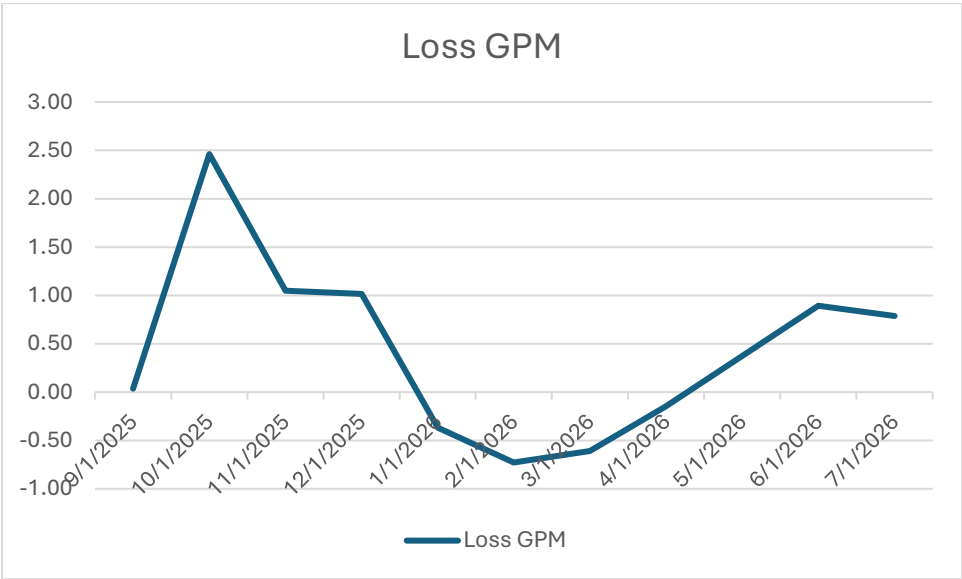
Distribution Overview (July 2026)

Master Meter Usage: 663,000 gallons

Distribution Loss: 35,155 gallons

Loss Factor: 5.30%

Gallons per minute loss: 0.79 GPM

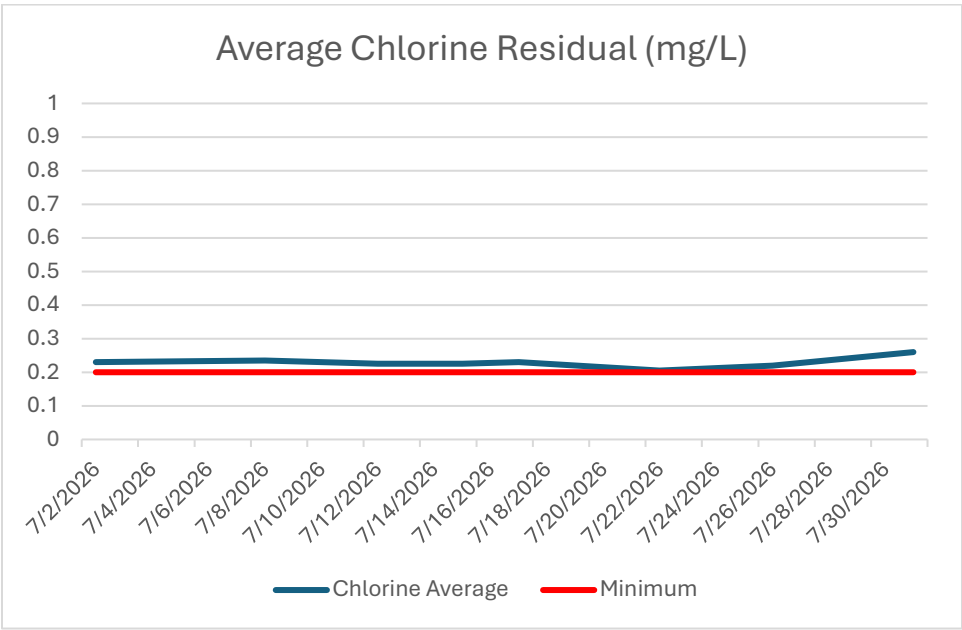
Chlorine levels

| | First User | Distribution System |
| Average | 0.23 ppm | 0.24 ppm |
| High | 0.25 ppm | 0.27 ppm |
| Low | 0.21 ppm | 0.20 ppm |
