Operations Report: Otter Rock March 2026

Base Operations

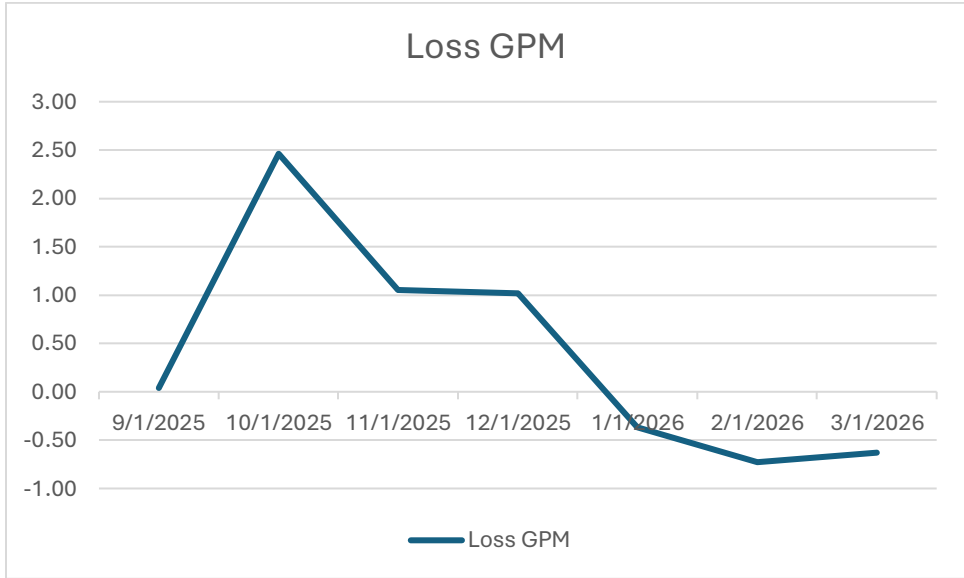
Distribution Overview (March 2026)

Master Meter Usage: 365,000 gallons

Distribution Usage: 392,234 gallons

Distribution Loss: -27,234 gallons

Loss Factor: -7.5%

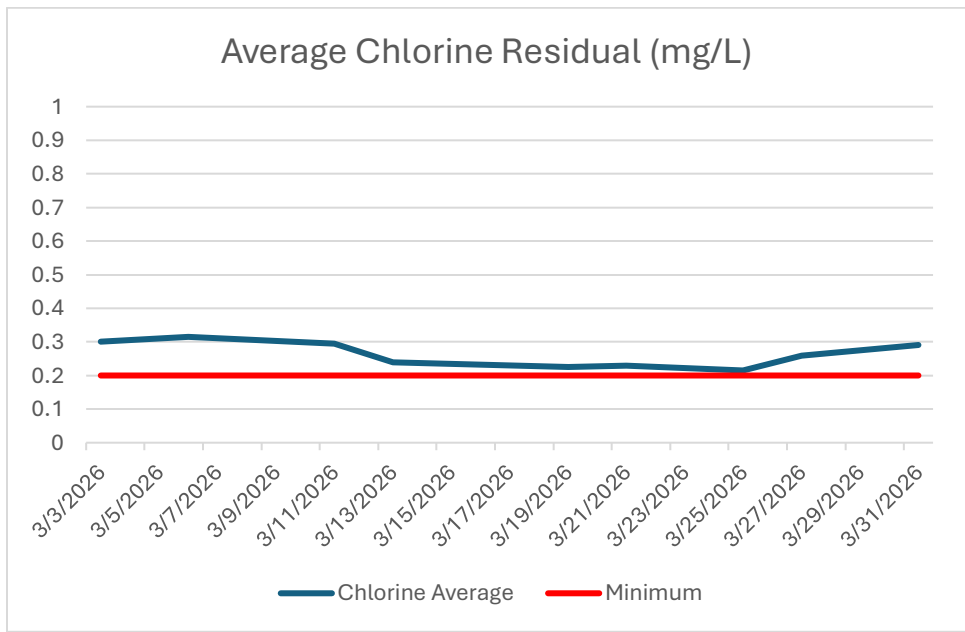
Chlorine levels

First User	Distribution System
Average	0.275 ppm	0.251 ppm
High	0.33 ppm	0.34 ppm
Low	0.22 ppm	0.20 ppm
