## Operations Report: Otter Rock Water District

August 2026

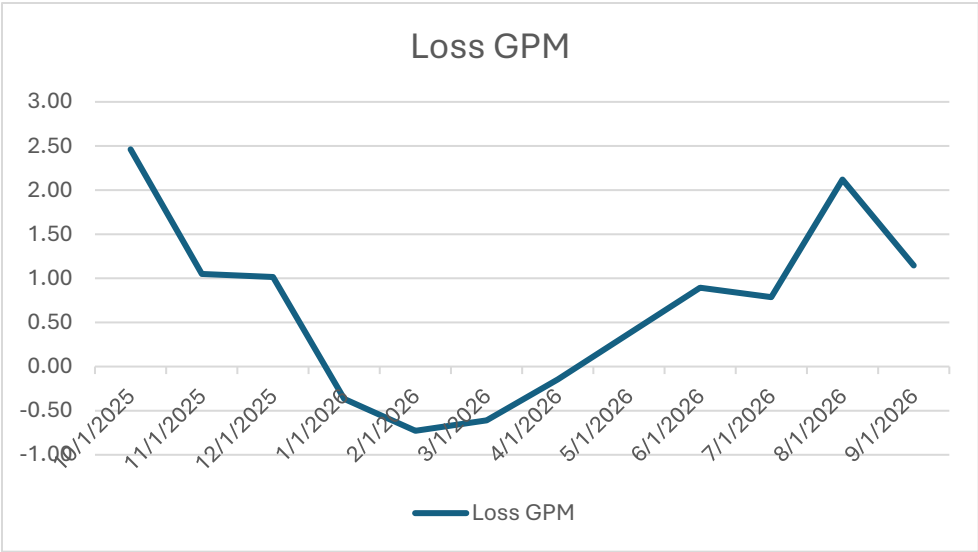
Distribution Overview (September 2026)

Master Meter Usage: 647,000 gallons

Distribution Loss: 49,480 gallons

Loss Factor: 7.6%

Gallons per minute loss: 1.15 GPM

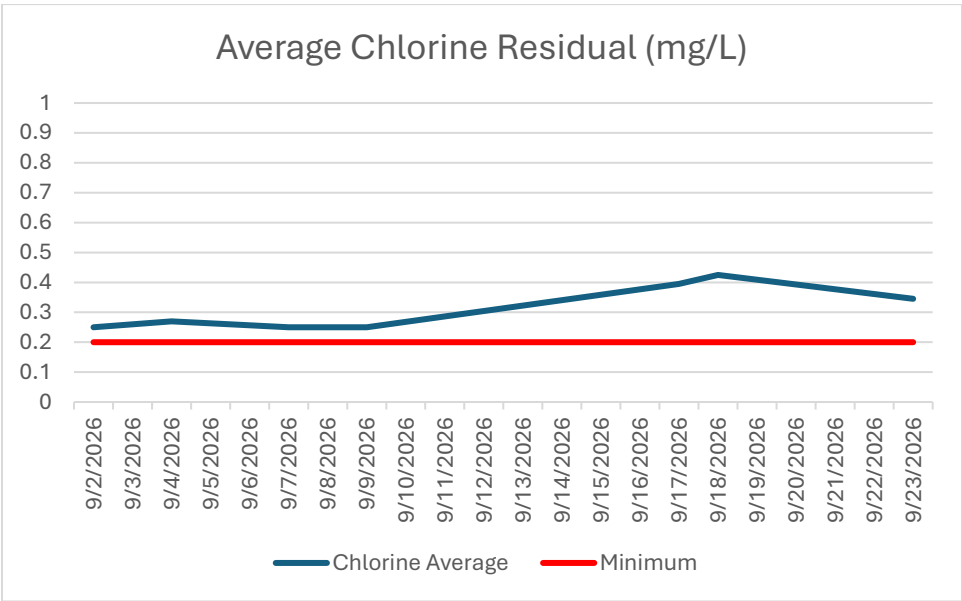
Chlorine levels

| | First User | Distribution System |
| Average | 0.32 ppm | 0.32 ppm |
| High | 0.44 ppm | 0.41 ppm |
| Low | 0.23 ppm | 0.24 ppm |
